Storedahl Daybreak Mine Groundwater and River Water Level Fluctuations

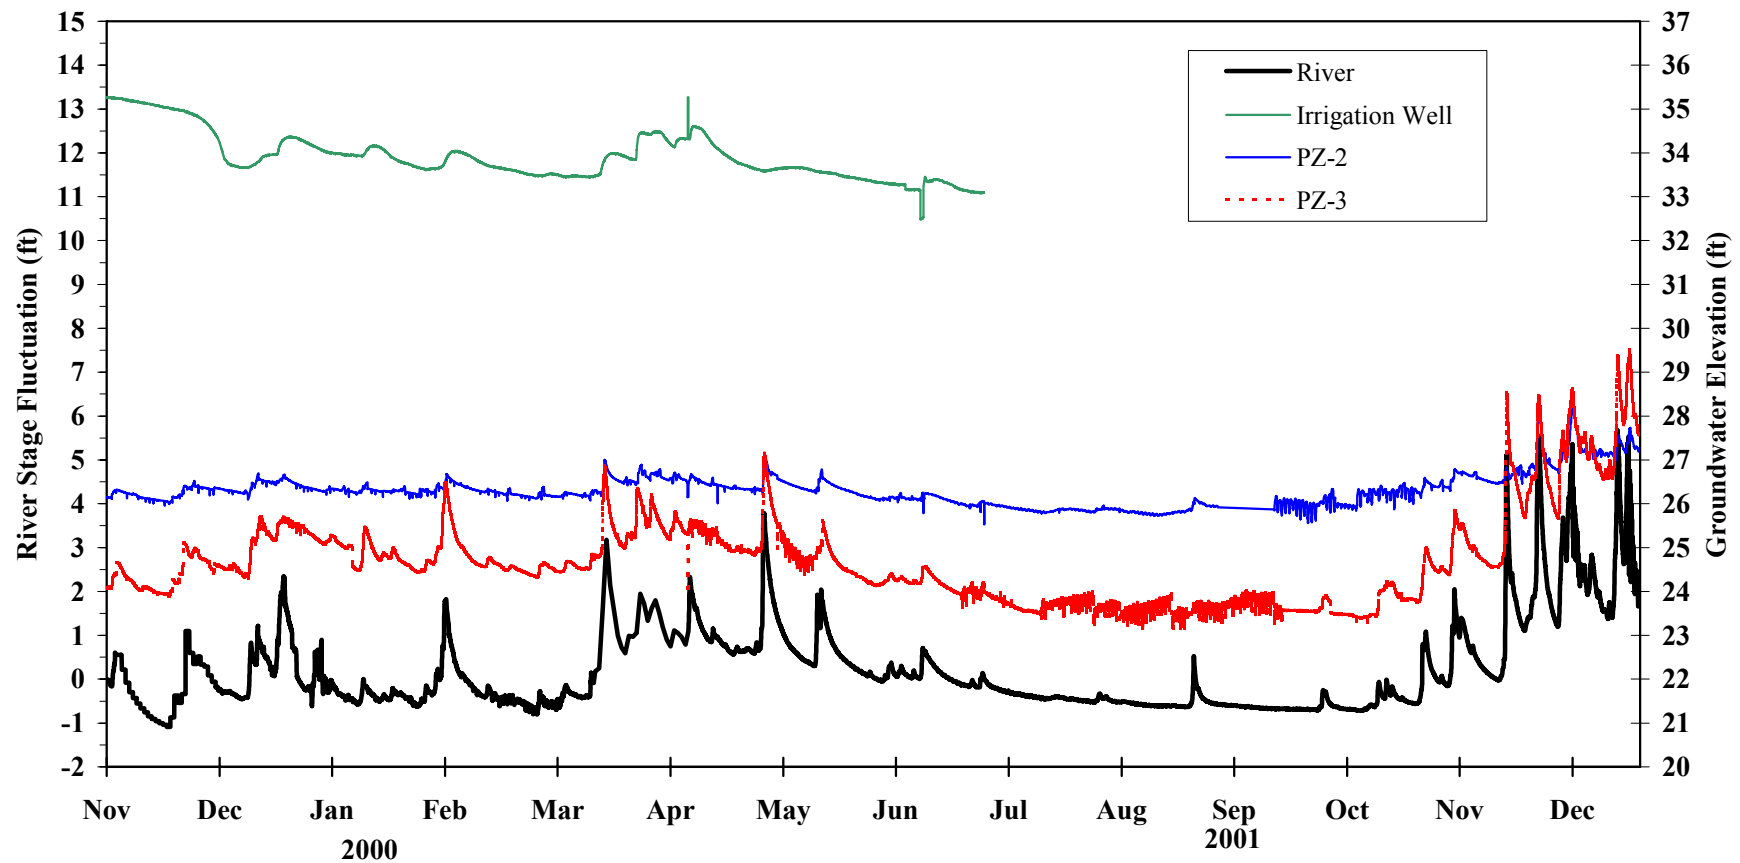
Figure 3-19: Fluctuations in groundwater elevations in piezometers PZ-2, PZ-3, the irrigation well and in the river stage measured from November 2000 through December 2001
